**Flood Control Project Maintenance
Levee Inspections**
LMA District Cover Sheet
Spring 2020 Levee Inspection Results

Levee District No. 0009 (Sutter County)

Levee Inspection Report By Mile - Spring 2020

Waterway	Bank	Unit Miles	Inspection Start/End	Inspector
Unit No. 01 Sutter County, Feather River	Right	6.25	03/17/2020 03/17/2020	Sterling York

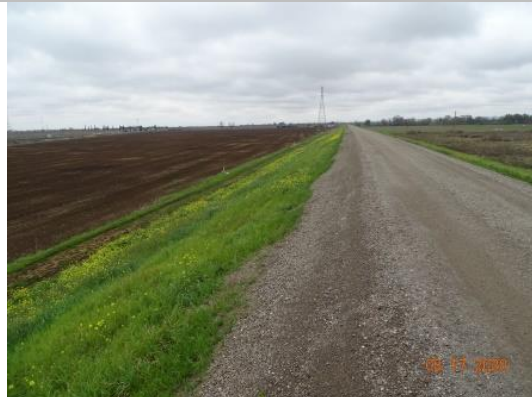
Photo 1 of 1 : SP_2020_LD0009_202_1_20200324_00004.jpg

LM Start	0.09	Rating **	A	Issue No.	1
LM End	6.24	Issue Type +	Ma	Location *	LS
Category	Earthen Levee			GPS Latitude/Longitude	
				Start	End
Item	Vegetation			39.170015 °	39.255723 °
				-121.622592 °	-121.636388 °
DWR ID	DWR_LD0009_01_s _ 2020_1				
Comment Code					
V1 : Control annual grass and weeds on the levee slopes and easements.					
Inspector Comment					
The annual vegetation is well maintained, Spring 2020.

View looking upstream landside of the well maintained annual vegetation, Spring 2020.

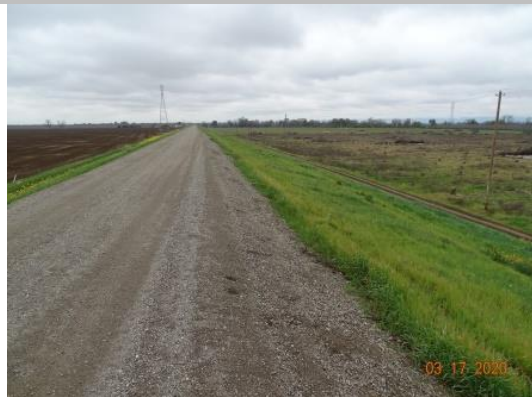
Photo 1 of 1 : SP_2020_LD0009_202_2_20200324_00003.jpg

LM Start	0.09	Rating **	A	Issue No.	2
LM End	6.24	Issue Type +	Ma	Location *	WS
Category	Earthen Levee			GPS Latitude/Longitude	
				Start	End
Item	Vegetation			39.170015 °	39.255723 °
				-121.622592 °	-121.636388 °
DWR ID	DWR_LD0009_01_s _ 2020_2				
Comment Code					
V1 : Control annual grass and weeds on the levee slopes and easements.					
Inspector Comment					
The annual vegetation is well maintained, Spring 2020.

View looking upstream waterside of the well maintained annual vegetation, Spring 2020.

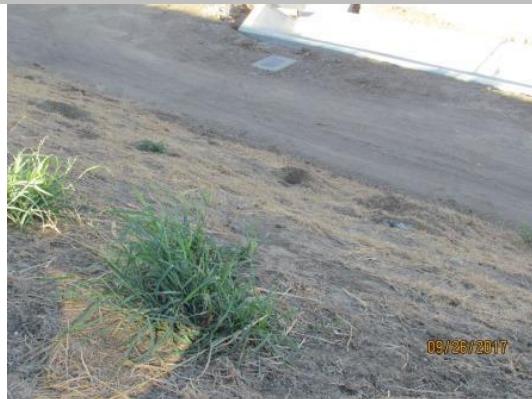
Photo 1 of 1 : SP_2020_LD0009_202_18_20200227_00001.jpg

LM Start	0.09	Rating **	M	Issue No.	18
LM End	0.09	Issue Type +	Ma	Location *	LS
Category	Earthen Levee			GPS Latitude/Longitude	
				Start	End
Item	Animal Control			39.170064 °	39.170064 °
				-121.622563 °	-121.622563 °
DWR ID	DWR_LD0009_01_f_2016_18				
Comment Code					
A3 : No rodents visible, but rodent burrows visible; need to backfill and compact or grout burrows.					
Inspector Comment					
No rodent activity was observed, holes need to be backfilled.

View on landside of rodent activity and holes.

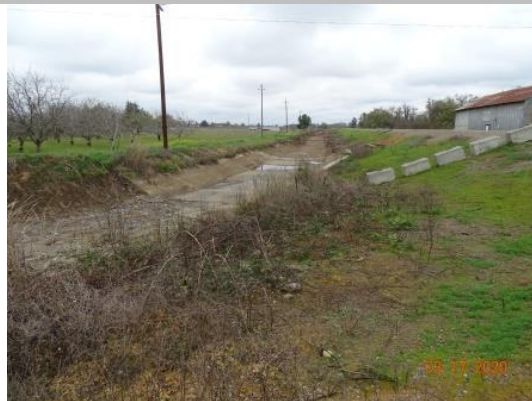
Photo 1 of 1 : SP_2020_LD0009_202_20_20200324_00005.jpg

LM Start	5.66	Rating **	M	Issue No.	20
LM End	6.00	Issue Type +	En	Location *	LS
Category	Earthen Levee			GPS Latitude/Longitude	
				Start	End
Item	Encroachments			39.247349 °	39.252258 °
				-121.637341 °	-121.637077 °
DWR ID	DWR_LD0009_01_f_2016_20				
Comment Code					
DT : Ditch					
Inspector Comment					
A ditch is located at the toe of the levee on the landside.

View looking upstream of ditch at the toe of the levee on the landside. The ditch erosion on the levee slope is scheduled for repair summer of 2020.
